Project SOCRAT
For visual non-destructive
inspection of reactor body
WWER-1000/320

Rivne NPP, Ukraine

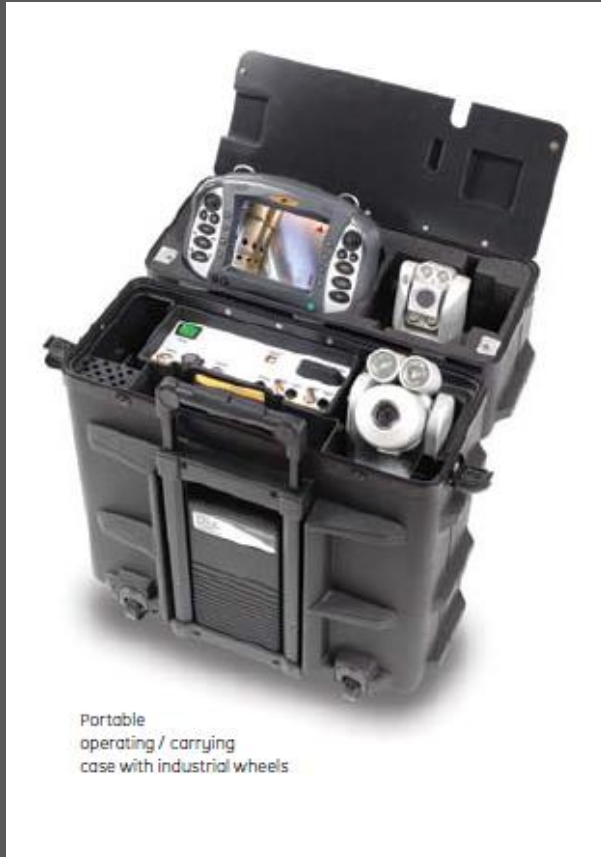
Portable
operating / carrying
case with industrial wheels

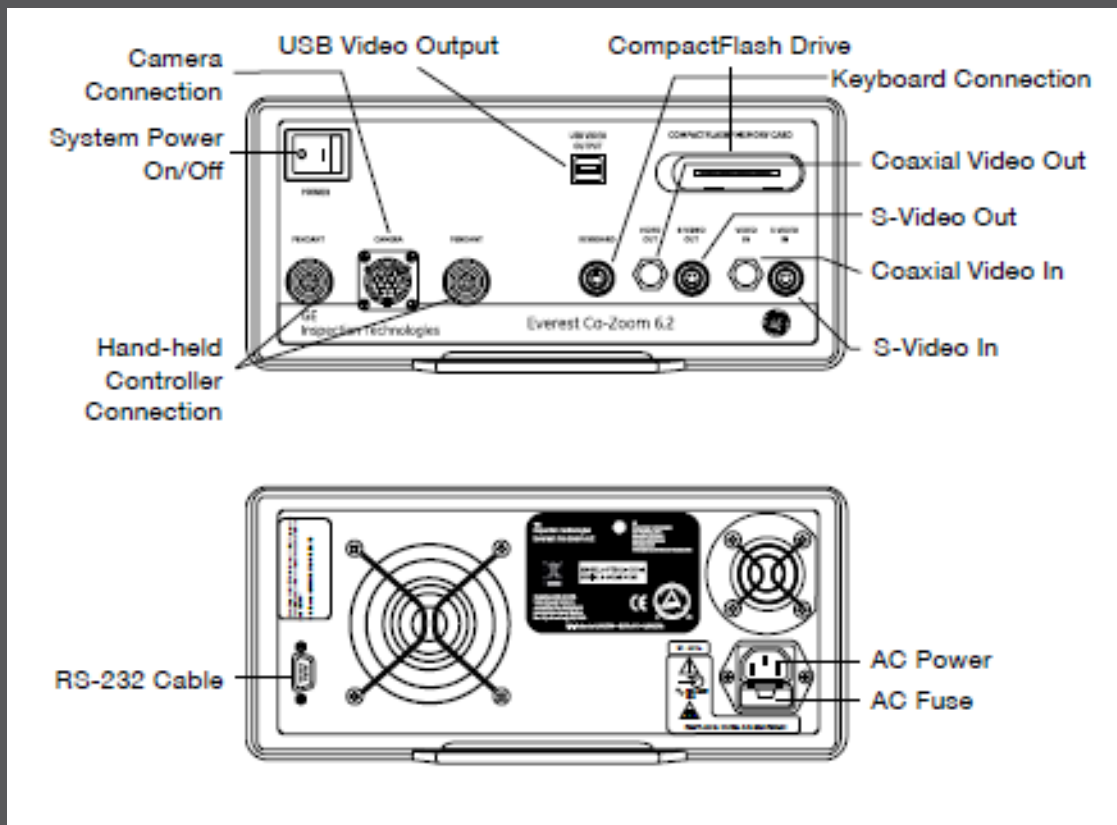
Camera control unit

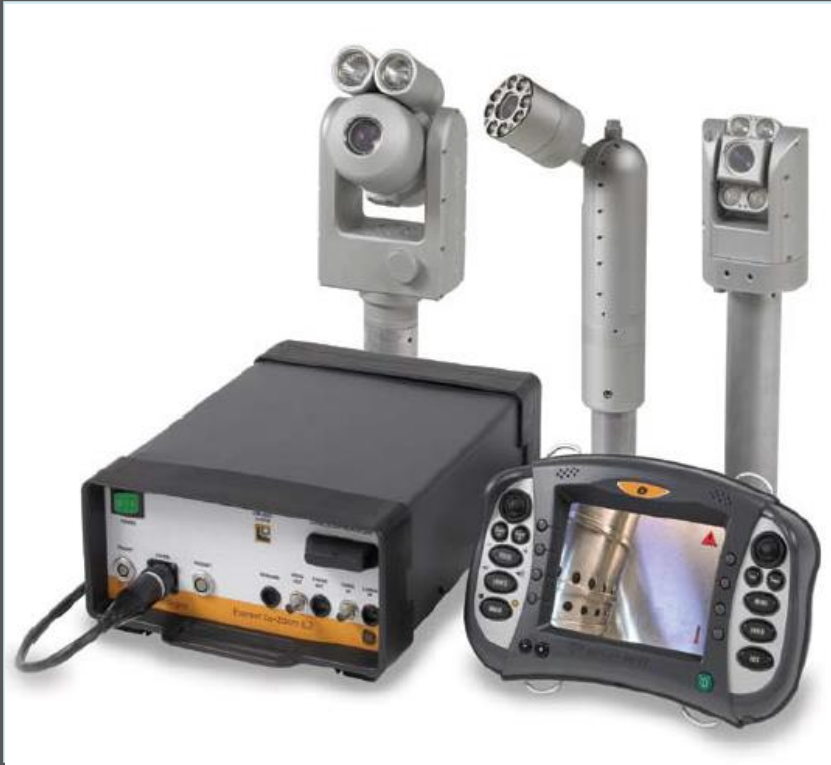
Camera Head Options

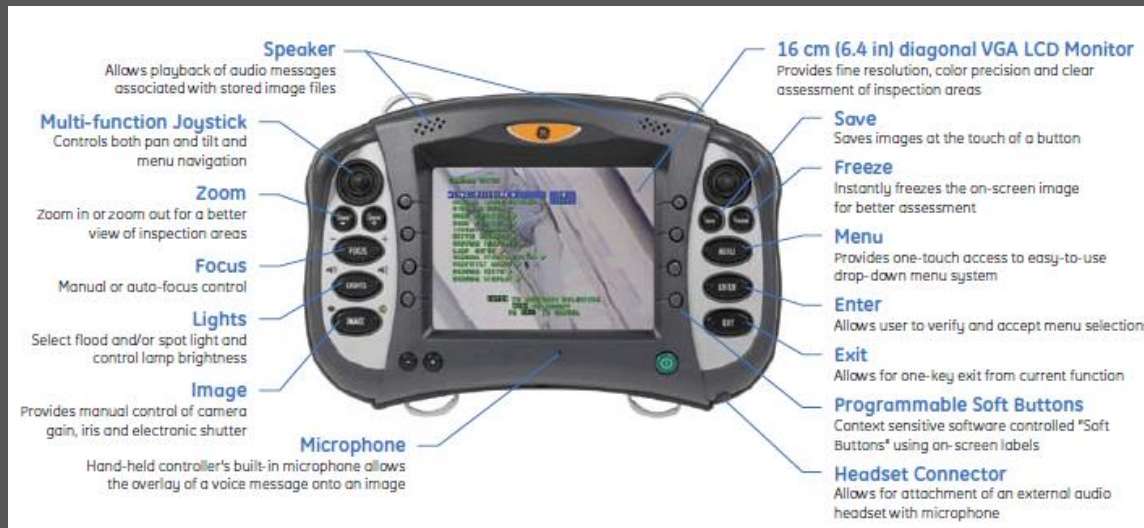
Hand-held Controller
